MISCELLANEOUS PAPER NO. 4-931

# XC-142A AIRCRAFT FLIGHT TESTS LANDING STRIP EVALUATIONS

October 1967

U. S. Army Engineer Waterways Experiment Station CORPS OF ENGINEERS

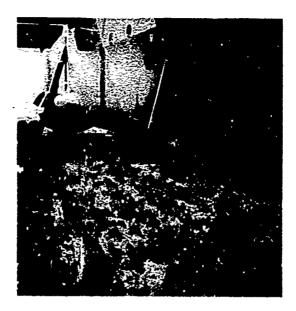
About 13 XC-142A aircraft operations were made at this site. On the fourth STOL landing (using maximum braking), the nose gear dug into the soil and was cocked fully to the left. The rut formed by the nose gear was approximately 16 in. deep, and the rut formed by the main gear was 1 to 2 in. deep. General views of the buried nose gear are shown in photographs 10 and 11. The aircraft made a vertical takeoff, as shown in photograph 12 (note cocked nose gear), and landed on the paved runway where it was learned that both nose-gear tires had been deringed and were flat, as shown in photograph 13. When the nose gear received a substantial side load, such as when the gear was cocked or on a taxi turn, the lateral force pulled the tires from the rim, and the air escaped. This will probably be corrected by the use of tube-type tires, which is planned for the future. It is believed that the tires were flat before the nose gear dug in completely. In later tests, both nose-gear tires were again derimmed and went flat on a taxi turn, and as the turn was

Photograph 11. Close-up of buried nose gear, Point Mugu, Calif. (south site)

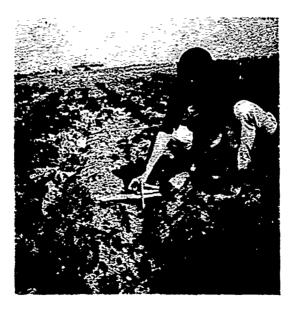
continued, the aircraft was again immobilized when the wheel rims cut into the soil. With the exception of the two incidents described above, the operation proceeded without difficulty. The average rut depth was 2 to 3 in., as shown in photograph 14. Some sod was broken loose (photograph 15) but did not create a hazard to the aircraft.

Photograph 14. Average ruts at Point Mugu, Calif. (south site)

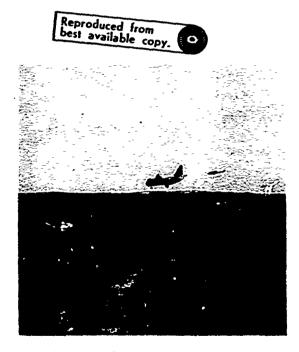
Photograph 18. XC-142A landing at desert test site near Edwards AFB, Calif.

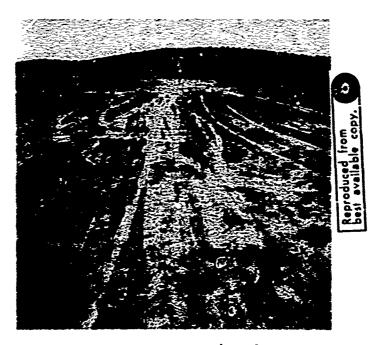
A general view and a closeup view of the TAC-2 runway are shown in photographs 22 and 23, respectively. Propeller damage caused by soil recirculation during operations from the CV-7 south runway and/or this site is discussed below.

Photograph 22. General view of TAC-2 (east) runway, Edwards AFB, Calif. This site was used for one STOL landing and one vertical takeoff
